Preservation of the Historical Saturn Rocket Artifact for Future Generations

Melissa K. McKinley, Johnson Space Center

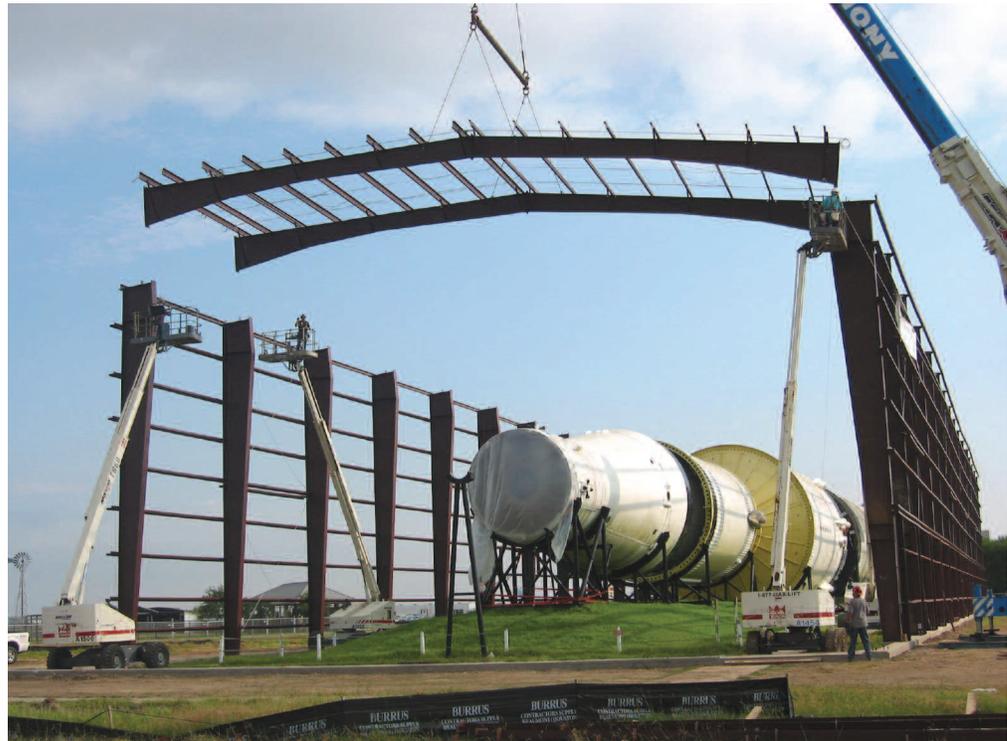
Lifting steel over Saturn V.

A crane lifted these preassembled sections over the Saturn V, and two crews of two iron workers worked from lifts to attach each section to the preset columns. Although the restoration effort was to follow construction of the building, paramount in everyone's mind was the potential damage that could result not only from a loss of the steel sections, but by dropping a tool or bolt onto the already aged and fragile artifact. Repairs could be done, but preserving as much of the original hardware as possible remained the goal.

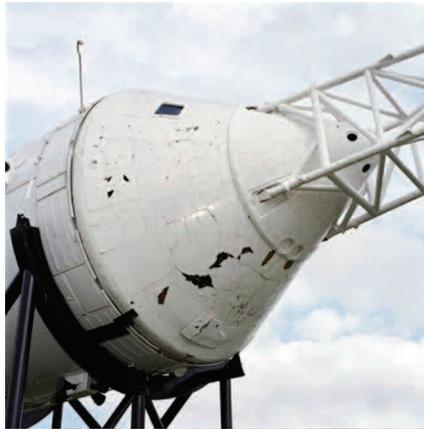
Concurrent with this activity, the pieces spanning the roof sections were assembled just east of the rocket display, and bolt-up was performed in sections of two bays. These were completely assembled on the ground to minimize the work over the priceless display. The greatest challenge of the construction phase then began.

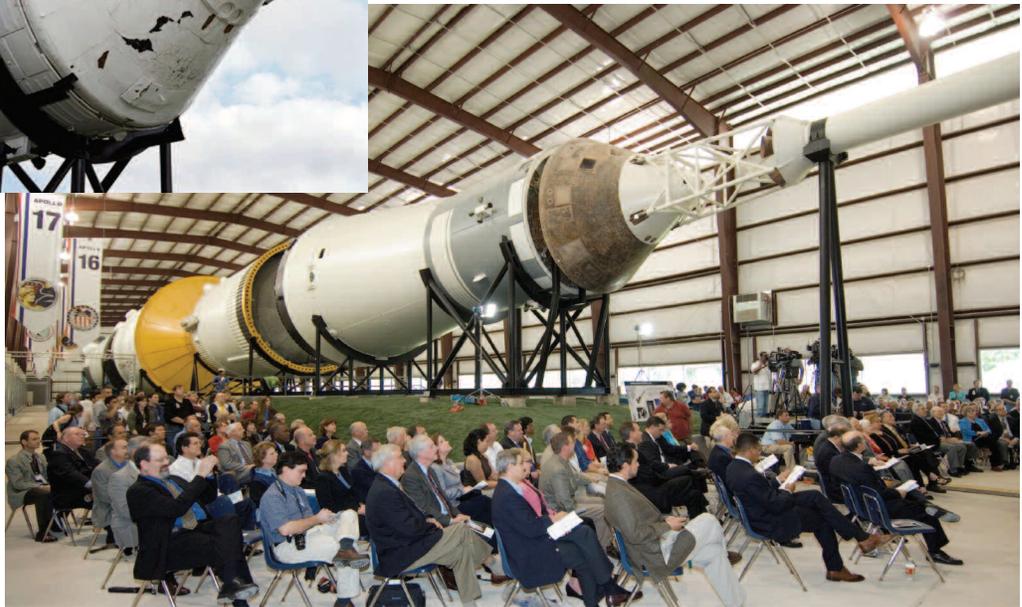
Before and after photos.

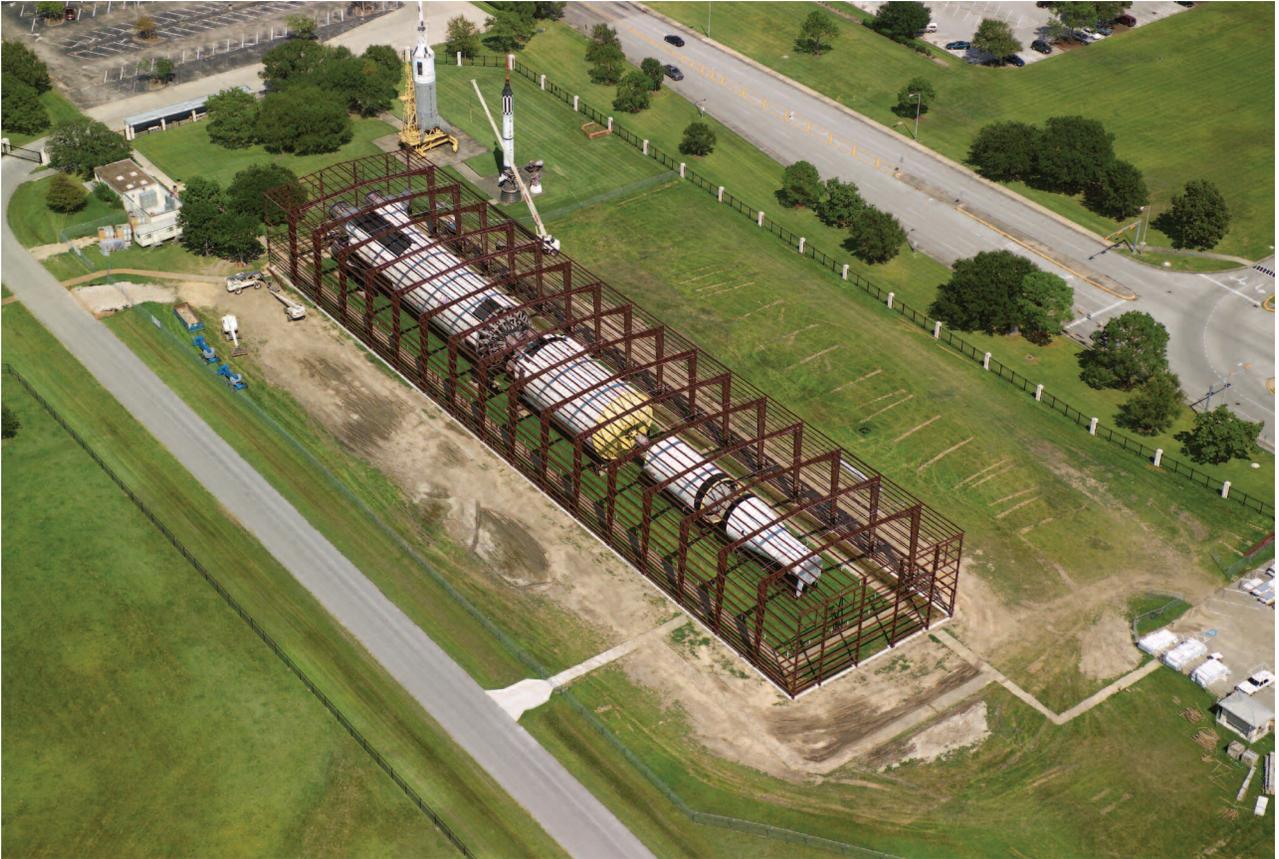
Completed steel erection.

Finally, the steel was in place. Although the remaining phases of construction, including the sheeting and roof installation, posed risks to the display, the riskiest phase was now complete. All team members had worked together to define each risk and eliminate it with controls. Each group of contractors focused on the task at hand and worked with all other groups to ensure coordination of tasks. The foreperson of the steel erection company commented, "I've built this building in my head many times. I've dreamed about it." The level of commitment was high, and no incidents were experienced during construction; safety or otherwise.
