Fuel Valve Pilot Seal Extrusion in Space Shuttle Primary Reaction Control System Thrusters

Jess Waller, White Sands Test Facility,
Johnson Space Center

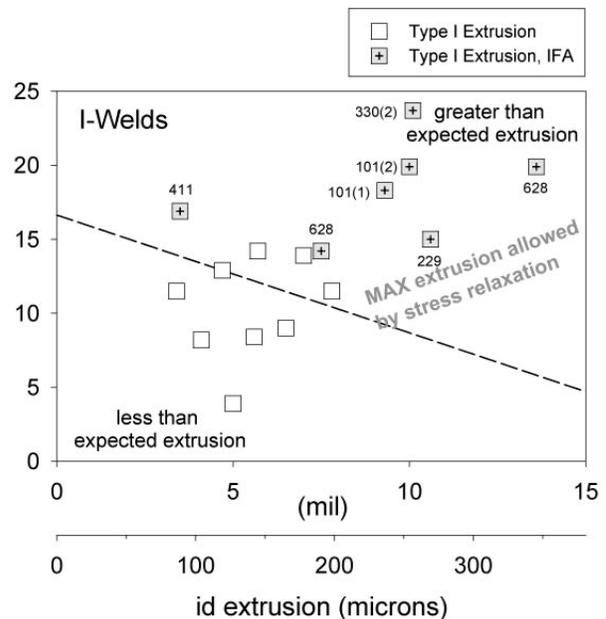
Observed (symbols) vs. predicted extrusion (dashed lines) for circumferentially welded (left) and intermittently welded (right) extrusion cases.

Estimation of the maximum allowable extrusion due the stress relief of the as-fabricated interference fit revealed that observed levels of extrusion often exceeded the theoretically predicted maximum, suggesting that factors other than thermally-induced extrusion or stress relief were contributing to extrusion (Figure 1). Intermittently welded pilot seat assemblies frequently reached higher levels of extrusion than their circumferentially welded counterparts despite having fewer years in service. Type I extrusion cases, exhibiting both pilot seal id and od extrusion, were determined to be a more advanced form of Type II extrusion (only exhibiting pilot seal od extrusion). Extrusion-related in-flight thruster anomalies were also determined to be of the more severe Type I extrusion category.
