Functional Cargo Block Structural Life Extension

James J. McMahon, Johnson Space Center

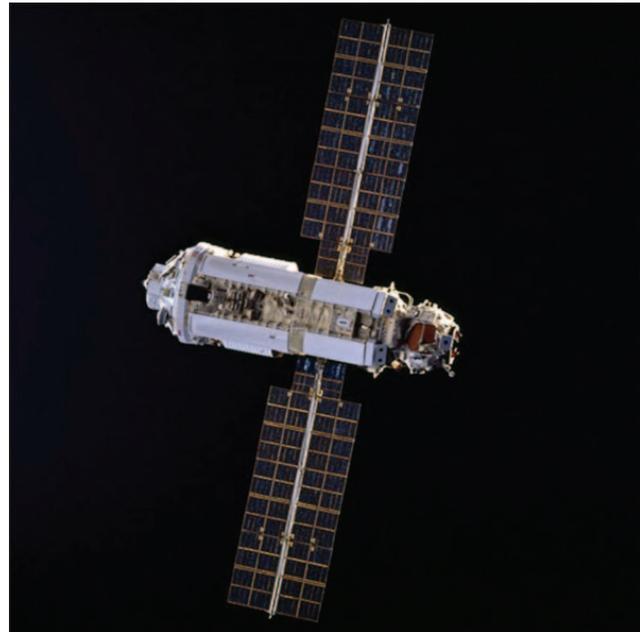
Fig. 1. The Functional Cargo Block on orbit.

The Functional Cargo Block—usually referred to by the Russian acronym FGB—was the first module of the International Space Station (ISS) to be launched. This event took place on November 20, 1998 (figure 1).

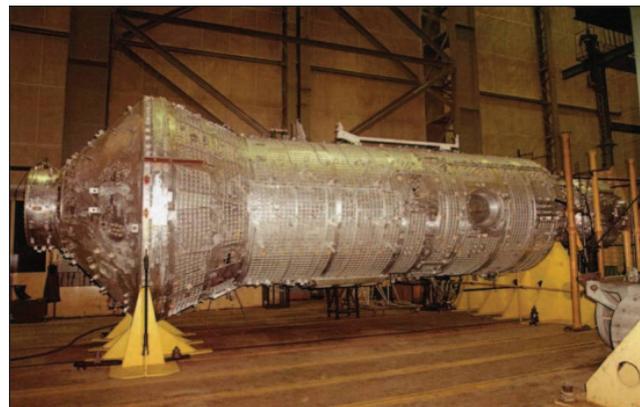
Fig. 2. The Functional Cargo Block.

The structural life of the FGB was certified using a dedicated fatigue test article. Three highly loaded interfaces were identified for testing. These locations were the forward end where the FGB attached to the pressurized mating adapter and the U.S. segment, the aft end where it attached to the service module, and at one of the two solar array attachment points. Engineers developed a design load spectra at each of these interfaces, which would envelop the actual load spectra to which the interfaces would be exposed. These spectra were then applied at each of the three interfaces one at a time with each set of three spectra representing a 15-year life. Since the Russians required a scatter factor of 8 on life, this procedure was repeated seven more times (figure 2).

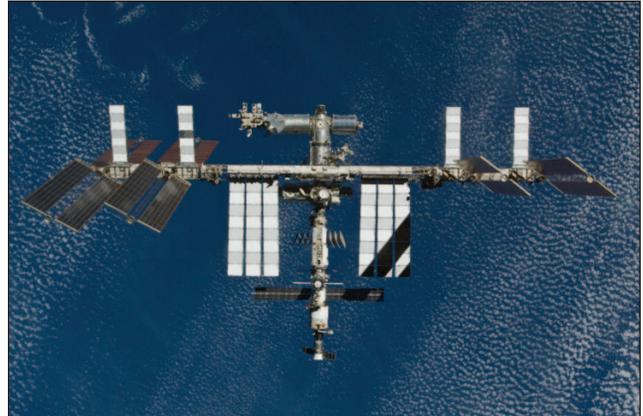
Fig. 3. The Functional Cargo Block with solar arrays folded.

While the FGB was not accessible during the life extension activities, the Russian partners retained their fatigue test article to allow for additional test cycles. Additional fatigue testing was done using the design spectrum at the forward and aft interfaces, which were run to a 2028 equivalent time frame. The solar array attachments were not included in this assessment because the FGB solar arrays were refolded due to an interference with the main radiators on the U.S. segment after the solar arrays were deployed (figure 3).
